Report No. CETHA-BC-CR-89048

Task Order 2 Enhanced Preliminary Assessment

NIKE BATTERY KANSAS CITY 30
PLEASANT HILL, MISSOURI

December 1989

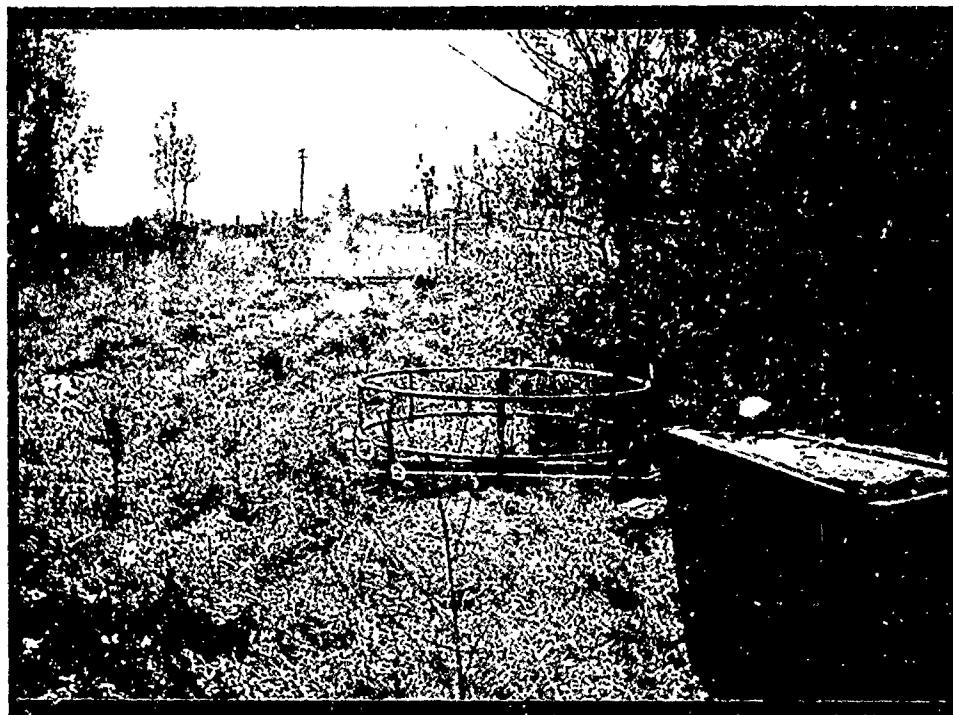
21. SEWAGE TREATMENT PLANT AREA

22. SEWAGE TREATMENT PLANT AREA

The outfall area may have been contaminated with acid, solvent, oil, and heavy metals from the various operations throughout the facility. Sampling for RCRA metals and TPH is recommended for these sediments at three locations. In addition, it is recommended that the Imhoff tank be cleaned.
